PLANT AUDIT REPORT

PLANT AUDIT PERFORMED FOR:			
PLACE:			
CONTACT:			
DATE OF AUDIT:	Preet Mijar & David Hewitson		
TYPE OF MATERIAL PROCESSED:		ESTIMATED ANNUAL TONNAGES:	1,500,000 TPA

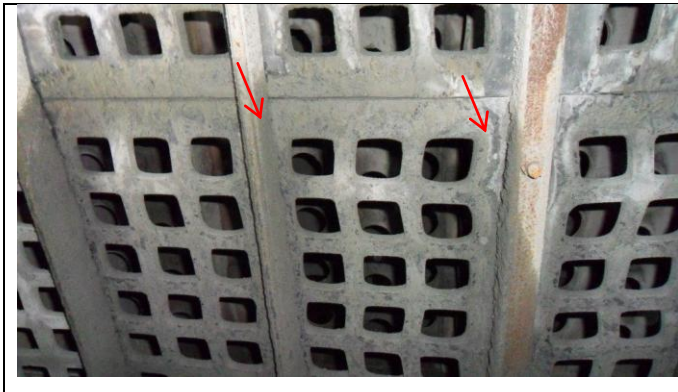
#1

Observation: *Simple design – lost screening efficiency and wear life*

Solution: Redesign maximising open area by using staggered aperture arrangement

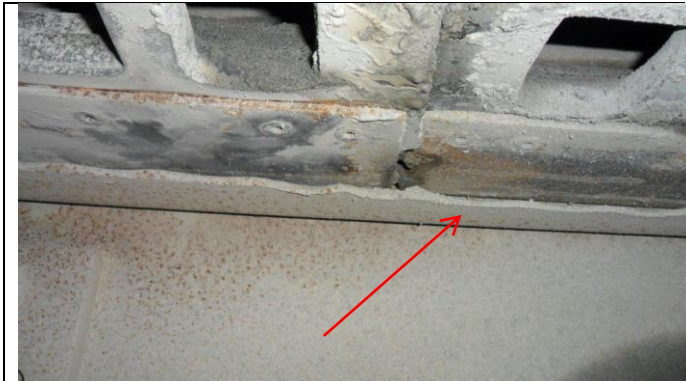
#2

Observation: *Side hook not sitting on side rail*

Solution: Check side clamping bars are correct profile and over-hook dimensions are correct

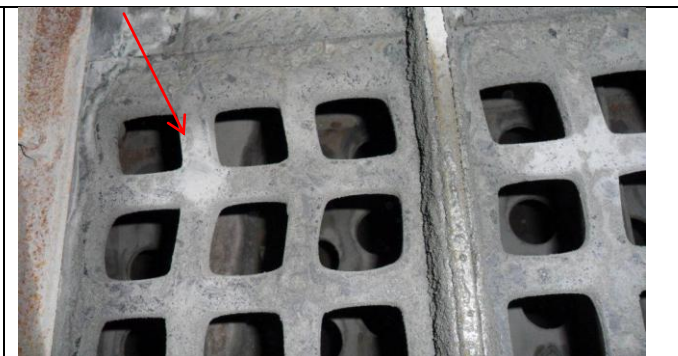
#3

Observation: *Sign of over-tensioning which could lead to premature failure through tearing of fabric plies or screen cloth pulling out of hooks*

Solution: Check side clamping bars are correct profile and over-hook dimensions are correct.

Ensure good crown and support bar capping rubbers are of the same profile

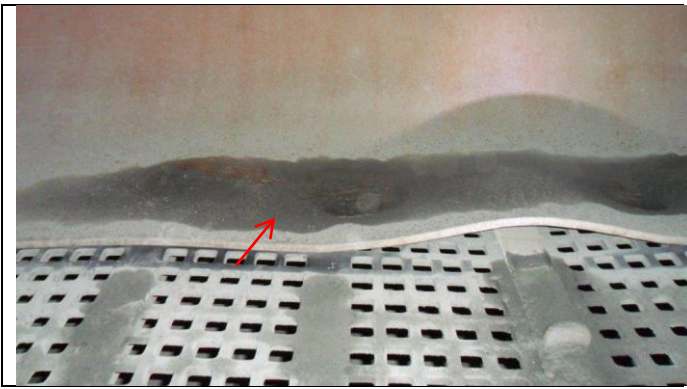
#4

Observation: Lost open area from rubber curtain. – nearly 50% of first screen cloth covered.

Solution: Shorten the length of the rubber so it is long enough to prevent spillage but short enough to expose all apertures

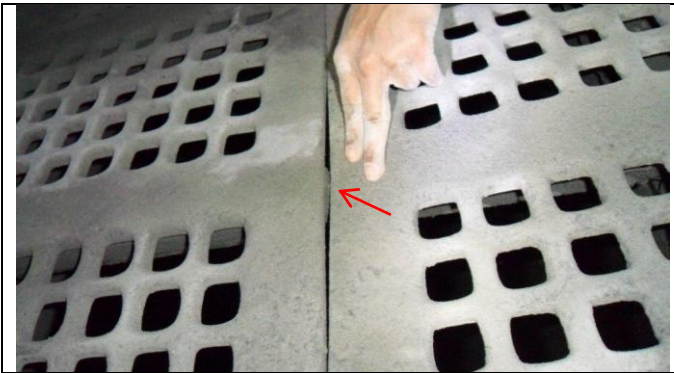
#5

Observation: Support bar capping rubber worn making it impossible to tension the screen cloth. This condition will result in premature screen cloth failure and poor screening efficiency

Solution: It is a good maintenance practice and cheap insurance to always fit new support bar capping rubbers when installing any new screen cloth

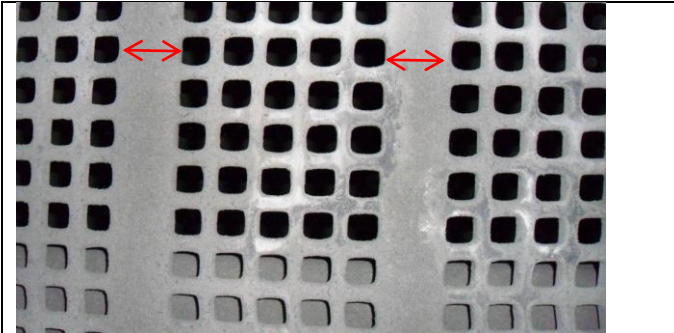
#6

Observation: Simple design – lost screening efficiency and wear life

Solution: Redesign maximising open area by using staggered aperture arrangement

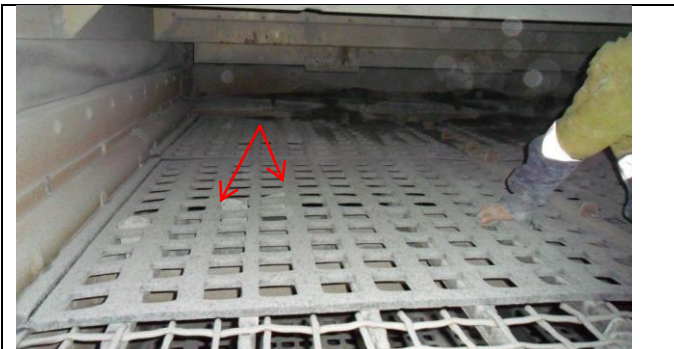
#7

Observation: Poor screen cloth design

Solution: Use off-set aperture arrangement and or redesign for easier installation

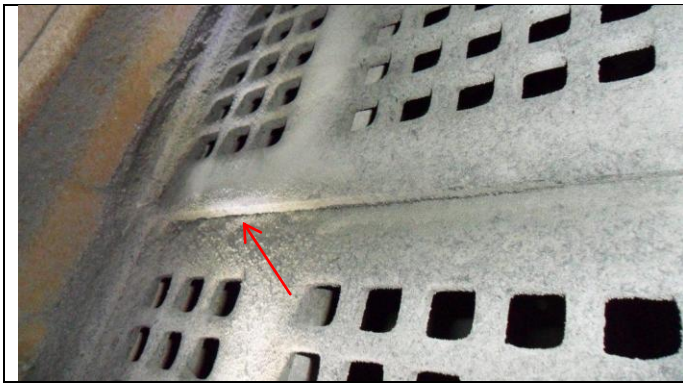
#8

Observation: Screen cloths not sitting evenly on the support bars

Solution: Check side clamping bars are correct profile and over-hook dimensions are correct.

Ensure good crown and support bar capping rubbers are of the same profile

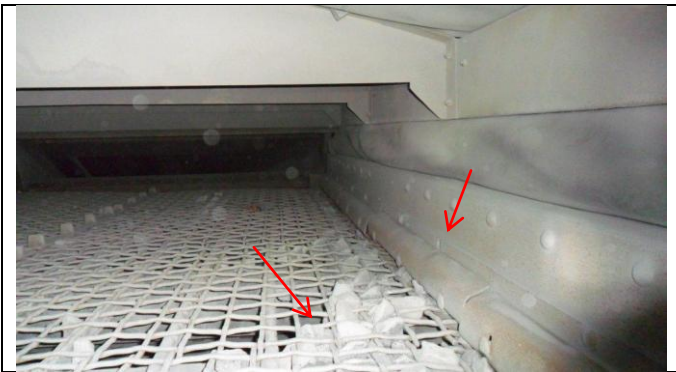
#9

Observation: Pegging. Concentric missing. Side clamps uneven. Very little camber

Solution: Consider self cleaning Flexmats to eliminate pegging and extended wear life.

Check side clamping bars are correct profile and over-hook dimensions are correct. Notice 2 different type of clamps.

Ensure good crown and support bar capping rubbers are of the same profile

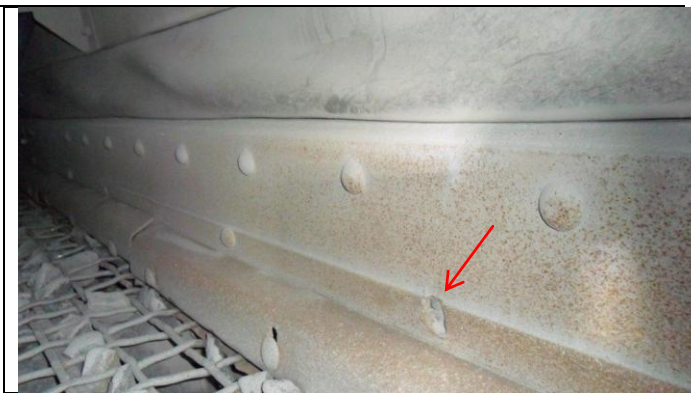
#10

Observation: Concentric missing. Concentrics are used to force the side hooks firmly down on the side rails

Solution: Re-fit concentrics

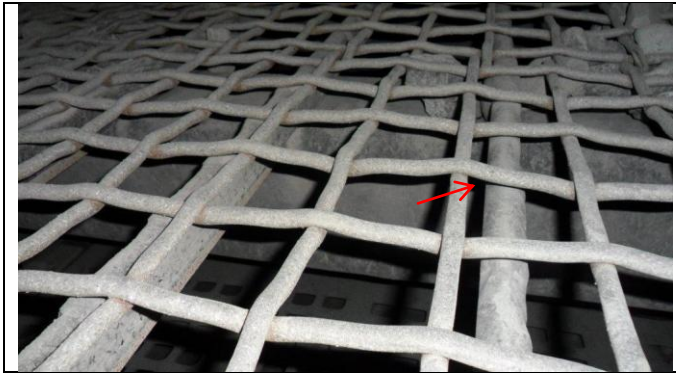
#11

Observation: Screen cloth not sitting on support bar capping. Notice how it is the closest support bar to the side clamp

Solution: Check side clamping bars are correct profile and over-hook dimensions are correct.

Ensure good crown and support bar capping rubbers are of the same profile

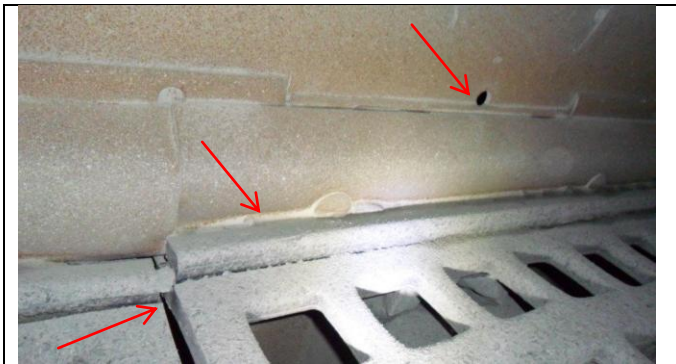
#12

Observation: Side clamp difficult to fit. Side hook not sitting on side support rail. Concentric missing

Solution: Extend steel hook plate on screen cloth by 15mm.

Re-fit concentrics

Check side clamping bars are correct profile and over-hook dimensions are correct.

Ensure good crown and support bar capping rubbers are of the same profile

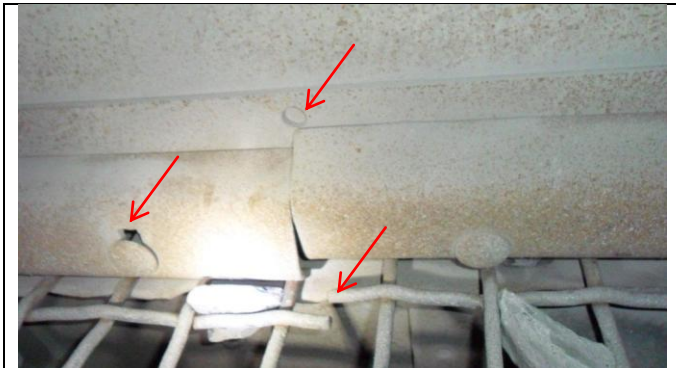
#13

Observation: Differing side clamps, screen cloth hard up against the side wall. Screen cloth not sitting on side support rail. Concentric missing

Solution: Re-fit concentrics

Check side clamping bars are correct profile and over-hook dimensions are correct.

Ensure good crown and support bar capping rubbers are of the same profile

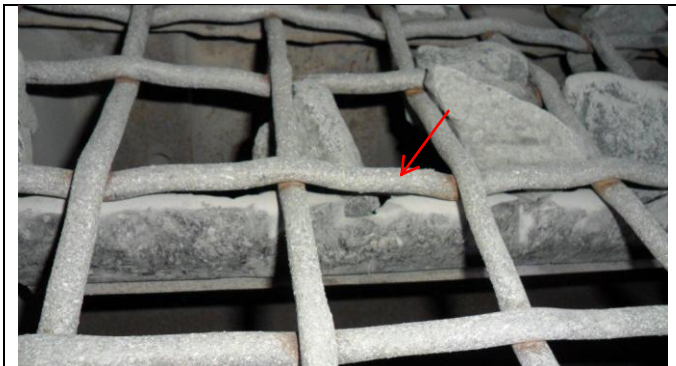
#14

Observation: Pegged rock not clearing the aperture resulting in wear to capping rubbers and steel support bars

Solution: Consider self cleaning Flexmats to eliminate pegging and extended wear life.

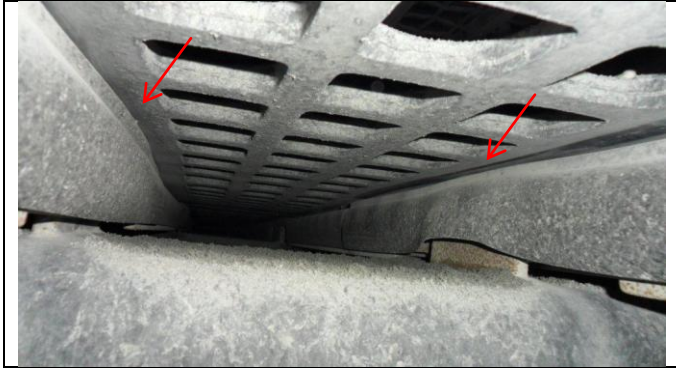
#15

Observation: Support bar capping rubbers not sitting flush on the support bars causing gaps between the screen cloths and capping resulting in difficulty in obtaining good cloth tension

Solution: cut away interfering sections of the capping

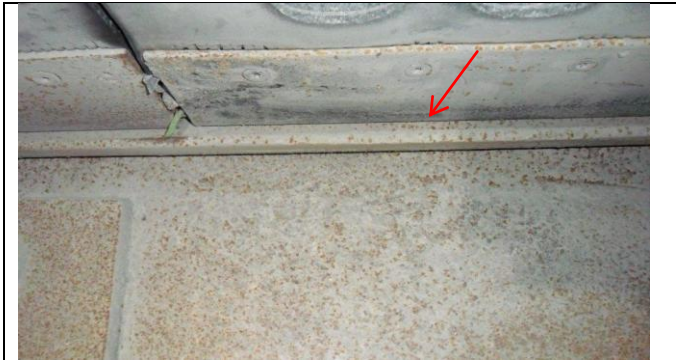
#16

Observation: Side hooks not sitting on side support rails

Solution: Re-fit concentrics

Check side clamping bars are correct profile and over-hook dimensions are correct.

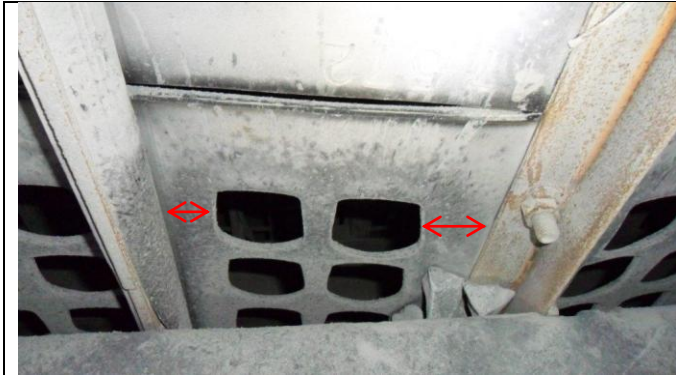
#17

Observation: Poor screen cloth design. Reduced wear life and inefficient screening

Solution: Better utilisation of the screening area available by staggering the apertures will give longer screen cloth wear life and increased screening efficiency

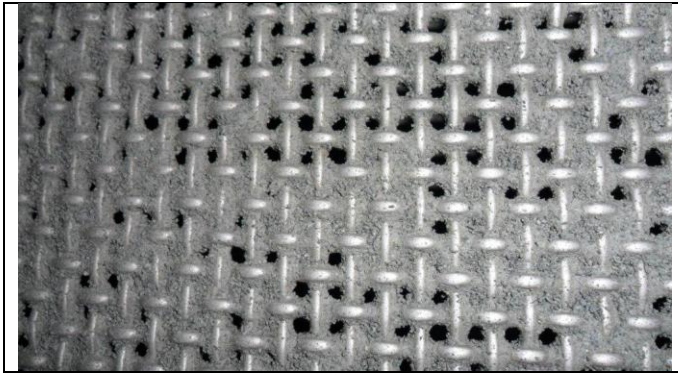
#18

Observation: *Wear* This photograph shows how the tops of the exposed woven crimps wear first. When the crimped wire wears thin the wires break and the cloths requires replacement

Solution: The flat vibrating wires of the Flexmats do not have any exposed crimped wires therefore they wear more evenly and commonly last 2-3 times longer than woven mesh with increased screening efficiency

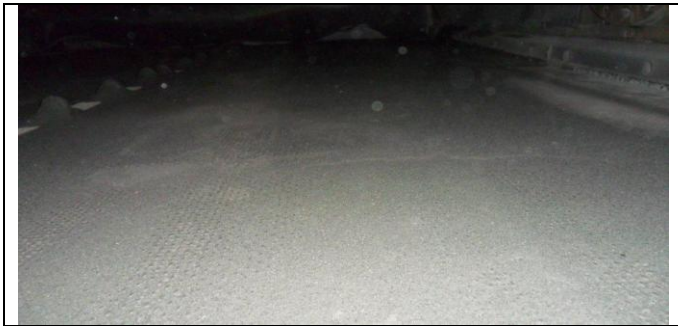
#19

Observation: *Extreme blinding of 5mm screen cloths.* It was reported that the blinding causes reduced production, unnecessary recirculating load, addition wear on crusher and additional wear in chutes

Solution: The flexible vibrating wires of our stainless steel SELF CLEANING Flexmats will eliminate blinding, significantly increase screening efficiency and return wear life several times longer than woven mesh
