PLANT AUDIT REPORT

PLANT AUDIT PERFORMED	For :		
Place:			
Contact:			
Date of Audit :	Audit By :	David Hewitson and Alain Charbonneau	
Type of material processed :	Roadbase	Estimated Annual tonnages :	unkown

Please see the attached findings from the site visit performed on Date June 17, 2011.

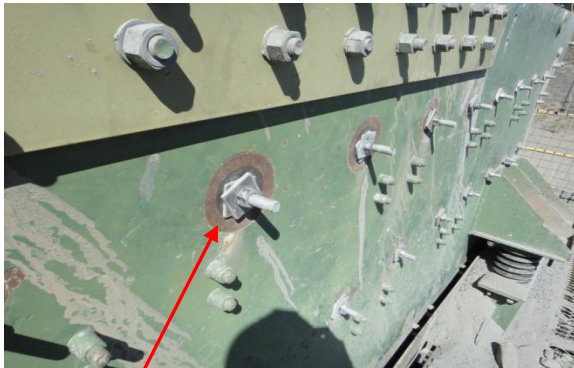
Image #1 Missing the right angle washer preventing adequate screen cloth tension

Solution: Add a concave washer or a right angle washer.

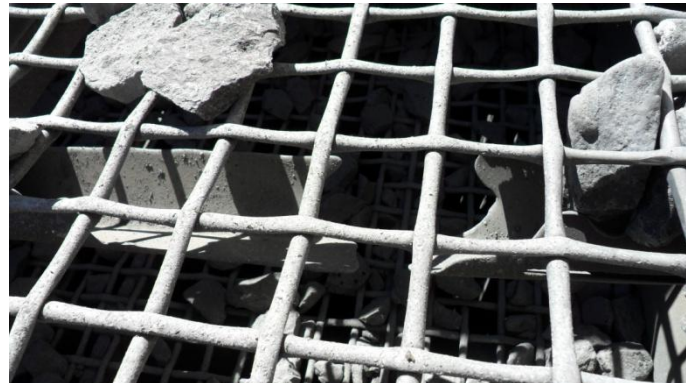
Image #2 The frame of the deck is worn and missing which is critical for the efficiency of how the screen cloth can be tight to the crown support.

Top deck - As you are most likely aware the top deck of your screen is in rather bad shape. It was explained to us that the contract is up for review in the next few months hence the reluctance to spend funds repairing a piece of equipment which may become redundant in the near future. However until that time arrives you still have to make do with what you have.

With the screen frame in its current condition your screen cloth consumption on the top deck is likely to be many times more than if the frame were in good order and proper cloth tension could be maintained.

Solution: Repair or replace frame. Possibility to future protect your frame with polyurethane or rubber sheet.

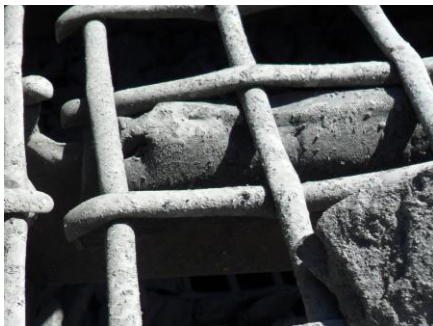
Image #3 Rubber channel are worn out.

Solution: Always change the support bar capping rubber with each new installation of screen cloth. A mix of old and new rubber you will give uneven screen crown (camber) making it impossible to get even tension over the whole screen cloth.

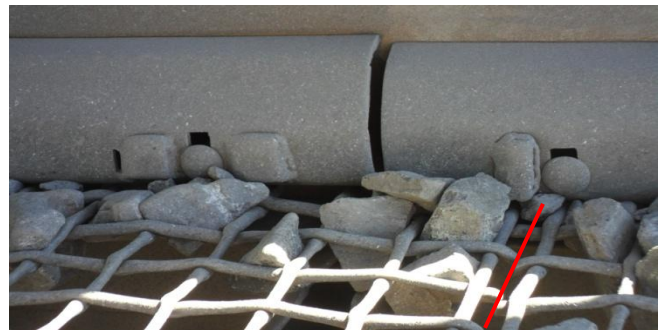
Image #4 One clamp rail overlapping on two screens.

The screen box is built to metric measurement 1500 x 3600mm and should use screen cloths 1200mm long. The cloths being supplied are 1220mm long which means that they are too long to fit the side clamping bars, further compounding the tensioning problems and wear life.

Solution: To have the screen length the same than the clamp rail. Presently clamp rail length is 1200mm and screen cloth are 1220mm. In future order screen cloths 1200mm long

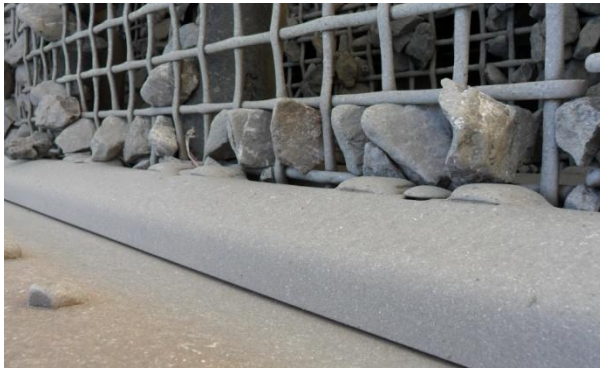
Image #5 Pegging problem on the top deck.

Solution: Replace woven mesh screen cloth with a self screening Flexmat cloth, that will eliminate the pegging problem and at the same time you will increase the action on the second deck to eliminate the pegging problem on the second deck.

Our Flexmats have a proven history in eliminating pegging and blinding. As an added bonus they usually last 2-3 times longer than woven mesh screens.

We recommend replacing your woven mesh screen cloths with high performance Flexmats

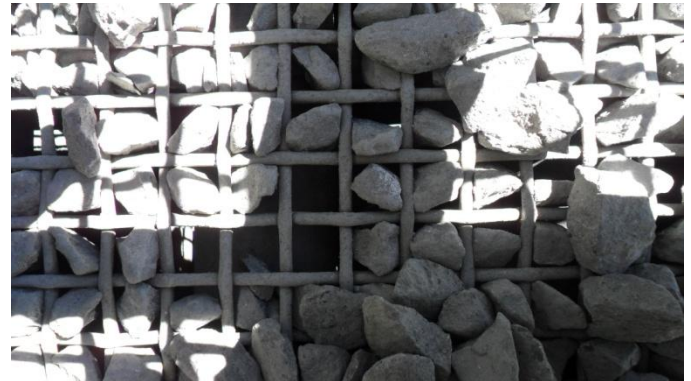
Image #6 Pegging problem on the bottom deck. Estimated at more than 50%

Second deck – very significant pegging on the 2nd deck is severely affecting screening efficiency. With around 50-60% of the apertures pegged there is a high volume of material being re-circulated unnecessarily. It is difficult to quantify what the cost would be in terms of additional wear on screen cloths, wear liners, crushers, conveyers as well as the additional power consumption. It may be the case that the entire screening plant operating time could be reduced by as much as 25% to produce the same volume of material. Fortunately there is a very simple solution to your pegging problem.

Solution: Install Flexmat self screening screens to eliminate the pegging problem, no need to clean the deck with a better performance and a cleaner material.

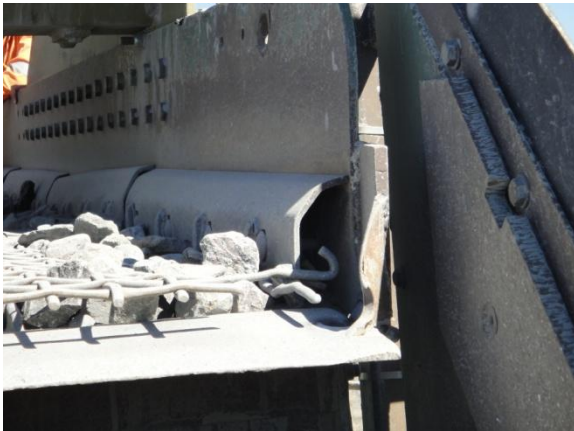
Image #7 Top deck - The hook is outside the clamp rail.

Solution: With the screen cloth the same length than the clamp rail (1200mm) you will eliminate this problem and gain better wear life for your screen cloth.

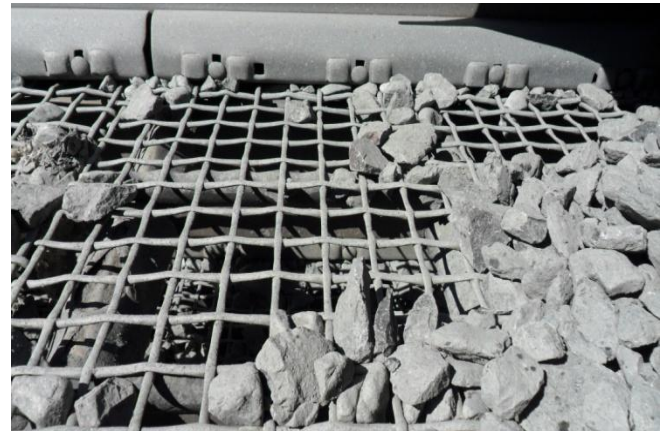
Image #8 Feed end can be a critical issue for screen wear life.

Solution: Install rubber screen cloth for the first panel of the feed end to receive the impact and at the same time that help to protect your frame.
